Intel[®] Pentium[®] III Xeon[™] Processor Specification Update

Release Date: March 2005

Order Number: 244460-039

The Pentium[®] III Xeon[™] processor may contain design defects or errors known as errata that may cause the product to deviate from published specifications. Current characterized errata are documented in this Specification Update.

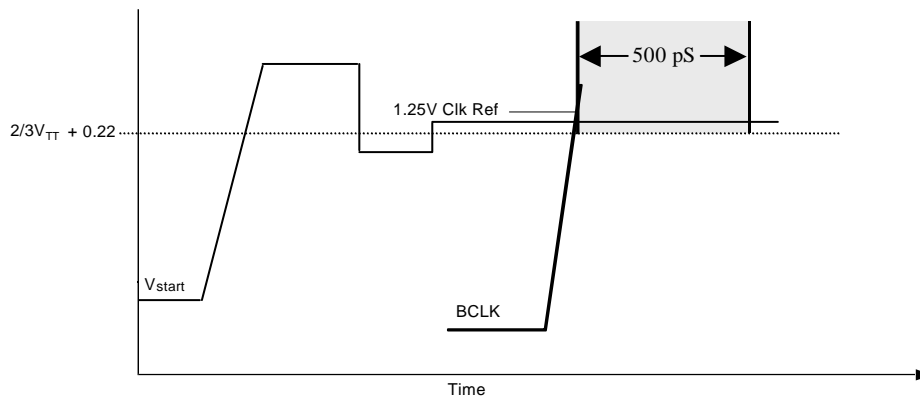
Intel has characterized the new AGTL+ AC specification for $V_{IH(MIN)}$ on the processor's RS0# signal to be: $(2/3 \cdot V_{TT}) + 0.22$ Volts within 500 picoseconds following the rising edge of BCLK crossing the 1.25-Volt threshold. See below.

Implication: The deviation from the published specification results in decreased noise margin on the RS0# processor input. This decreased noise margin has been observed to be particularly detrimental in system environments where the RS0# processor input is being driven by an I/O buffer with a pull-up device (such as a p-channel transistor) that is switched off mid-cycle. Systems that employ I/O buffers that keep the pull-up device on for the entire cycle are significantly less affected by this erratum. The reduction in noise margin may lead to the generation of BINIT# (when enabled) resulting in a system reset, otherwise this condition may lead to a system "hang" condition.

Workaround: If a system design cannot meet the specification deviation, the following areas should be carefully examined to assure that additional margin exists in order to compensate for any deficit observed with respect to the newly characterized $V_{IH(MIN)}$ specification:

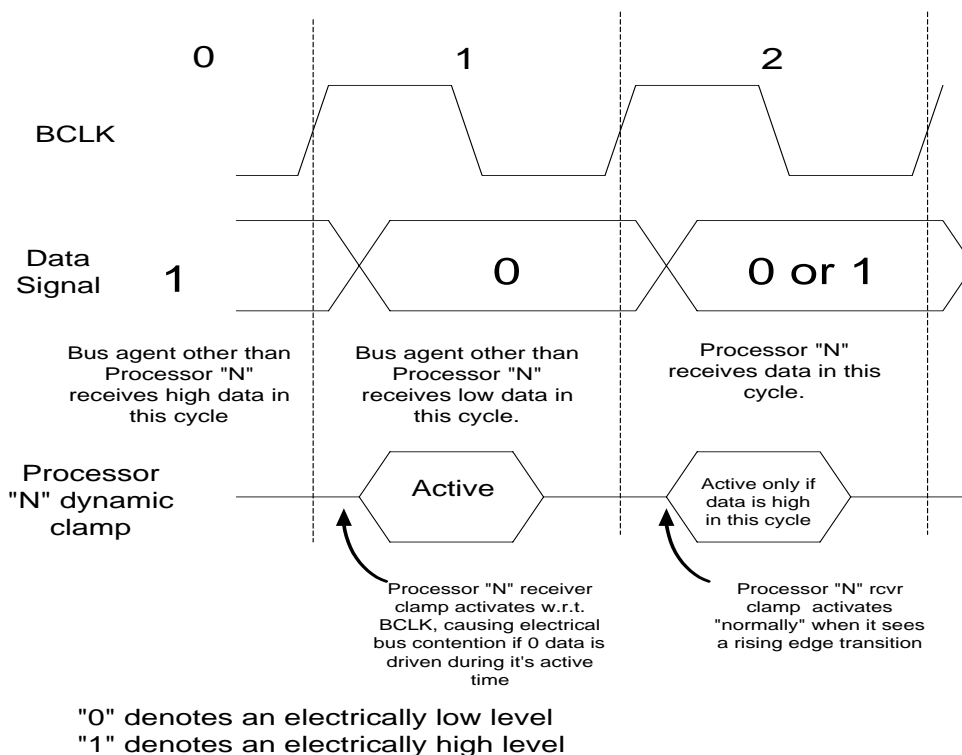
Problem: Falling edge ledge push-out and undershoot may be seen on AGTL+ data and data bus ECC signals. The AGTL+ receiver's dynamic clamp circuit activates (i.e. clamps the signal to an electrically high level) in certain cycles when data is driven to an electrically low level by another agent.

Implication: This erratum only occurs on a processor that does not receive data in that particular cycle. More specifically, this erratum only occurs when a specific processor does not receive data in the current BCLK period, but receives data in the very next period. Therefore, the processor inducing this falling edge noise (on data and data bus ECC signals) will not actually read the data in that cycle. See below for an illustration of this erratum affecting a processor denoted Processor "N". The falling edge ledges and undershoots may affect the signal quality and/or timing at agents that receive data in that cycle. Therefore, the impact of this erratum is highly dependent on system bus design.

Workaround: Evaluate system bus signal quality and timing margin at the valid receiving agent as a result of this falling edge noise. Due to dependence upon system bus design, bus layout may be evaluated to determine the need for improvements in signal quality and timing margin at the valid receiving agent as a result of this receiver-induced falling edge noise.
